Project 2: *Repairs to 15th Century roof at St. Peters' Claybrooke Parva, Leicestershire, Diocese of Leicester*

Listing Status: *Grade 1*

Client: *PCC St. Peter's Church Claybrooke Parva,
The vicarage,
Claybrooke Parva, Leicestershire*

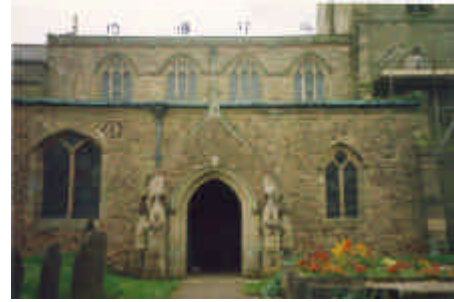
- Two truss ends on the northside had been decimated by death-watch beetle and were no longer bearing on the wall.
- The supporting wall posts were also in a fragile state.
- The south east corner post and brace were structurally unsound.

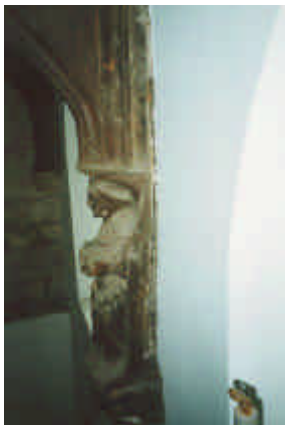
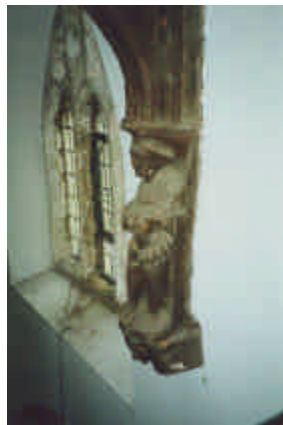
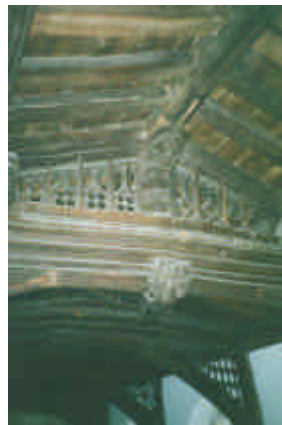
1. Based upon the findings from the quinquennial reports observations, a platform lift was hired to inspect the trusses over the nave to the church

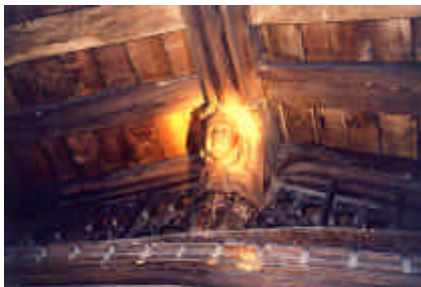
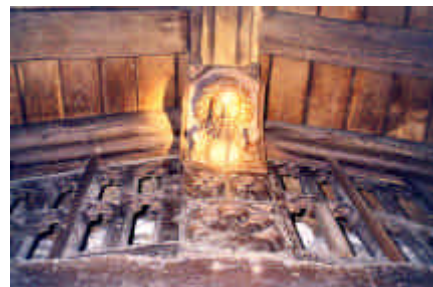
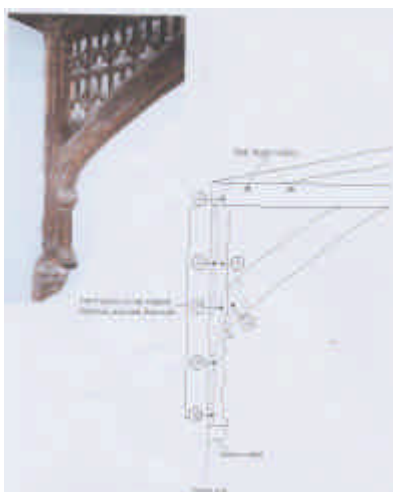
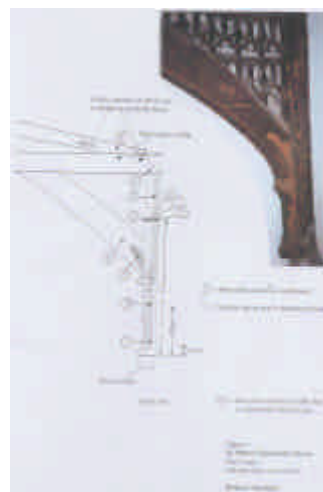
2. Messrs Ridout who are timber specialists and ourselves inspect the trusses more closely than a ground-based quinquennial could and photographically record the findings

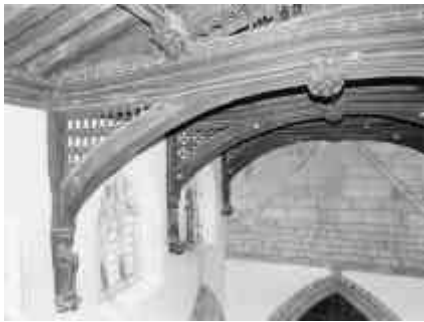
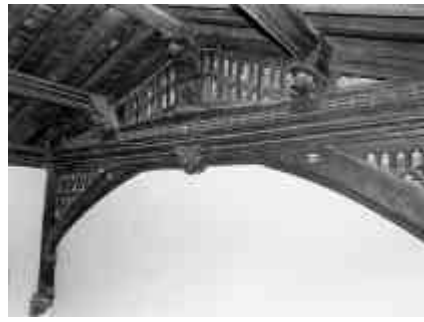
3. Pressure drillings were taken and a report prepared outlining the extent of the damage to each truss that could not be seen without actually opening up the structure

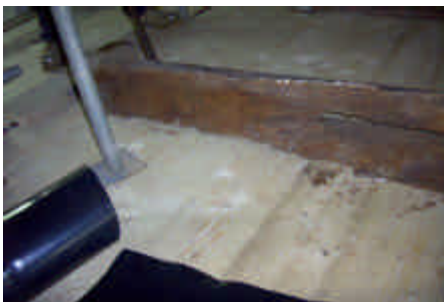
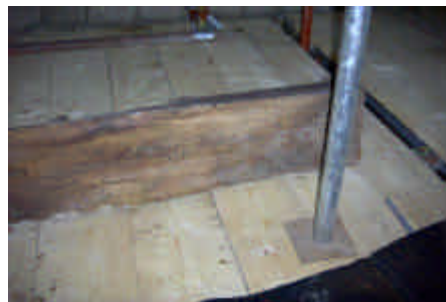
11. These photographs show the extent of the damage to the rear of the posts

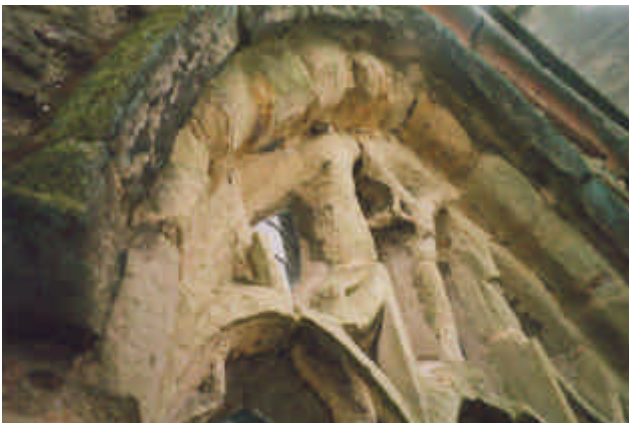
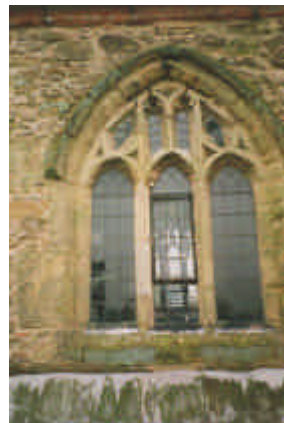
13. These photographs show the extent of the damage to the tracery of the clerestory windows. During the repair of the trusses and whilst the scaffolding was in place

14. It was decided that during the repair of the trusses and whilst the scaffolding was in place (internally) that repairs should be made to the tracery
