## **Project Details**

Project 1: *High Level Repairs to St. Peter's Church, Witherley  
Diocese of Leicester*

Listing Status: *Grade 1*

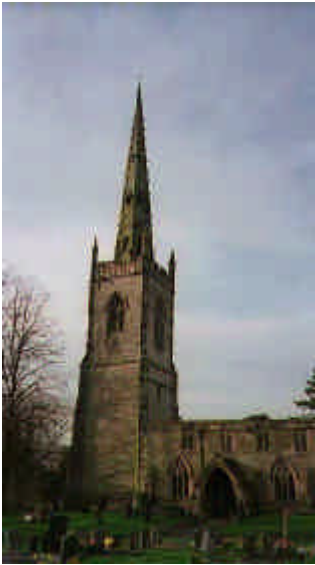
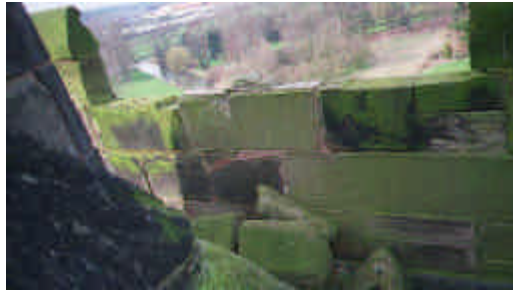
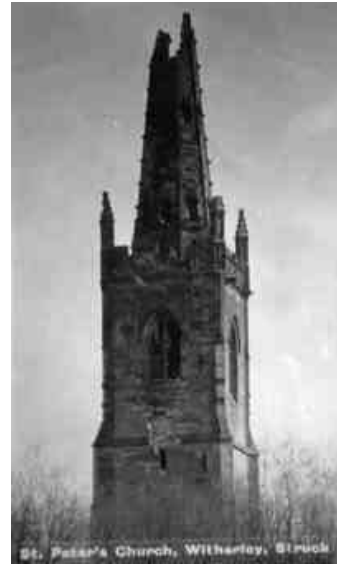
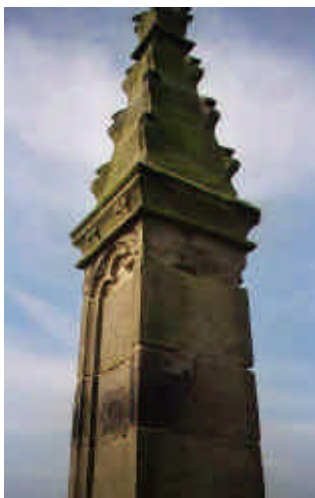
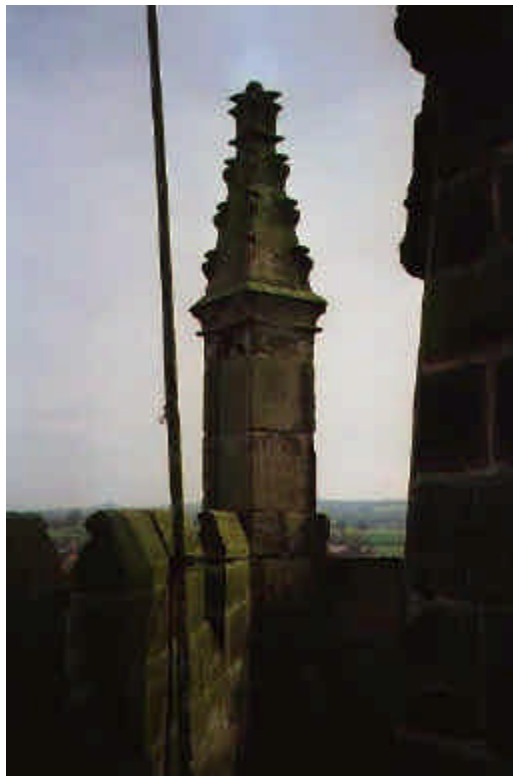
1. During the quinquennial inspection the battlements to the tower were found to be in a dangerous condition (as shown top centre), some merlon stones were removed for safety purposes during the inspection. Three of the four substantial corner pinnacles were noted to be rotating and out of plumb, the northeast corner being at approx 225mm off vertical. The pinnacles cantilever out from the frieze work and the weight of the pinnacles had over the years caused the base stones to displace. The spire had been struck by lightning in the 1930's and the upper section reconstructed shortly after.

2. Drawings of each elevation of the battlements were prepared and for tendering purposes areas of stones work, which would require replacing, were identified.

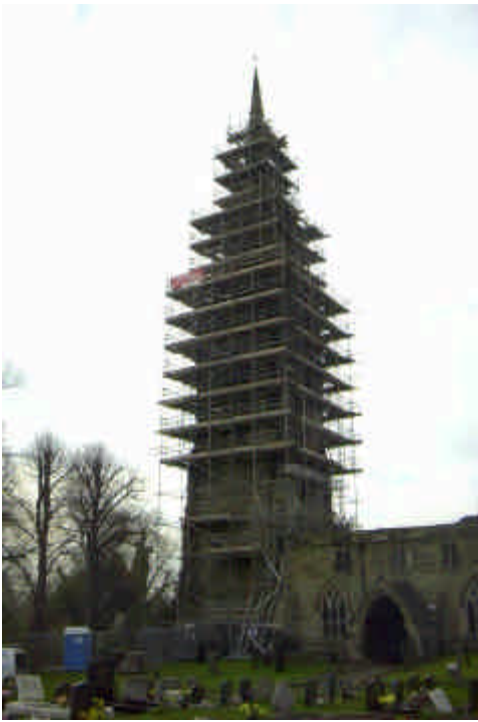
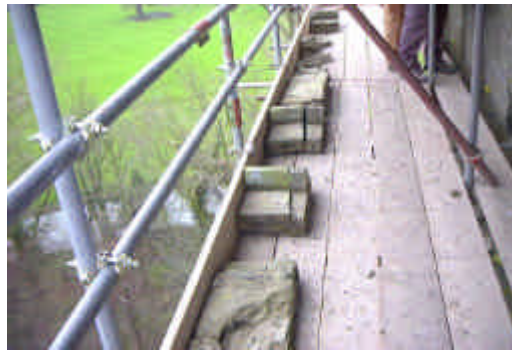
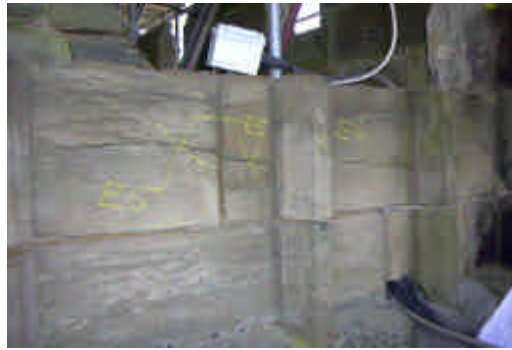
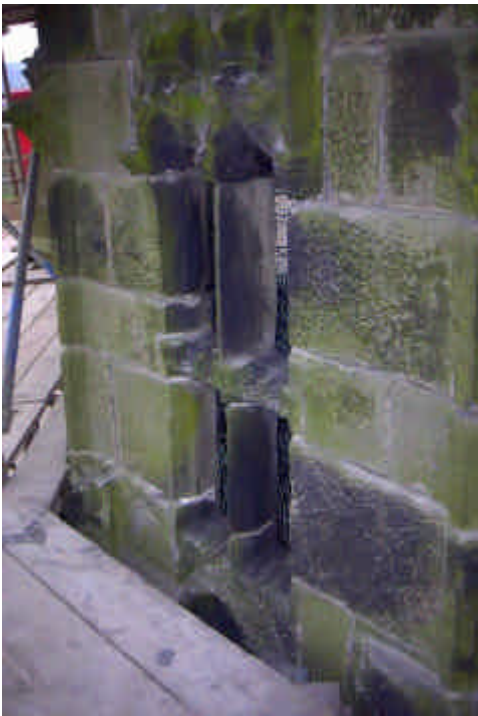
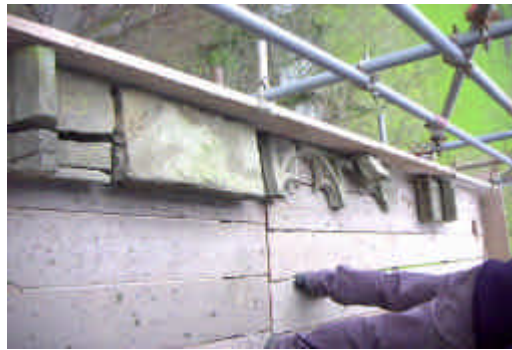
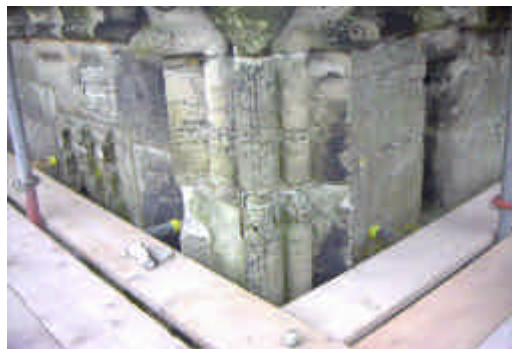
3. Although the spire appeared to be in reasonable condition stonework to the lucarnes had been identified in the quinquennial it was decided that due to the height of the tower scaffold would be continued up to include the spire to allow for work to the lucarnes. During the erection of the scaffold the scaffolders reported that the whole of the upper section of the spire appeared to be loose. Close inspection indicated that this movement was related to the 1930's repair and incorrect mortar specified to the rebuild.

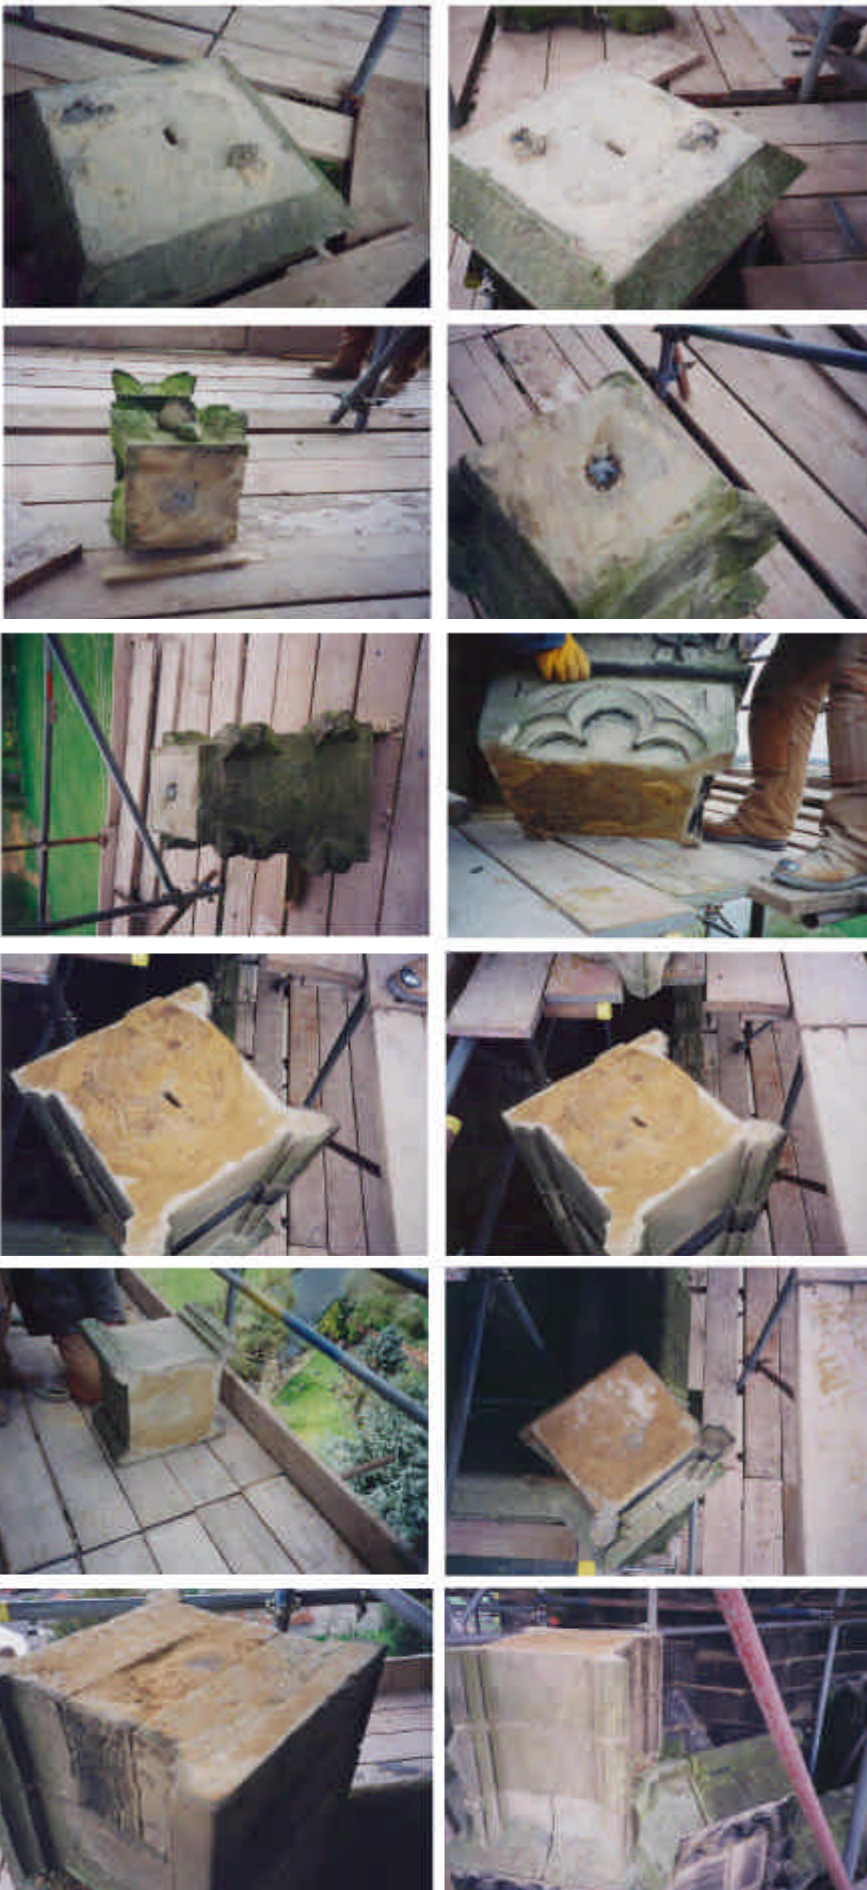
6. Close inspection of the pinnacles showed that all but the pinnacle adjacent to the tower stair were showing signs of distress in the lower courses and their staging. Following discussions and agreement with EH inspecting Architect Mr. Cox it was decided to carefully disassemble the three pinnacles. Stones were carefully numbered for reassembly.

7. The base of the pinnacles were distressed due to poor initial and original construction and the use of too small sections of stone which give only limited bonding to other elements of the tower walls.

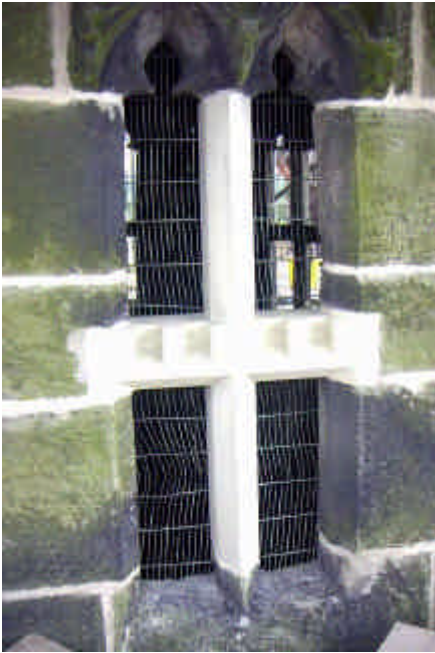
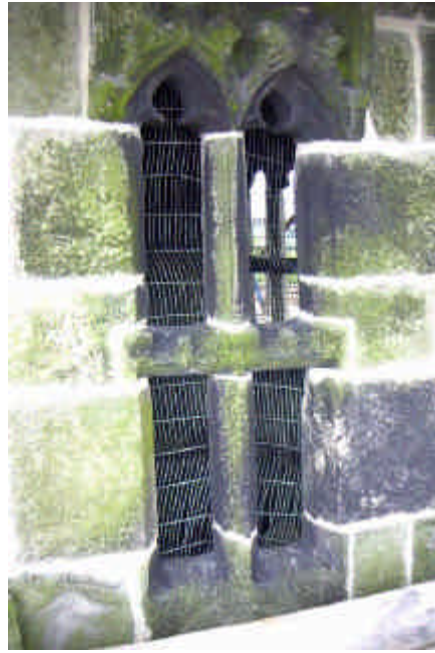
10. The original stone used at Witherley was Attleborough, which was a quarry near Nuneaton, but this went out of production many years ago. The closest match is Woodkirk, which is quarried near Leeds, Woodkirk is a more sound and consistent stone compared with the Attleborough which is soft and tends to delaminate along its bed lines.
