Project Details

Project 4: *Restoration and Conversion, Listed Barns with Central Tower forming the Home farm to Kelham Hall which was designed by Sir George Gilbert Scott in 1858*

Listing Status: *Grade II*

Client: *Civil Service housing association & Jelson Homes, Loughborough Road, Leicestershire*

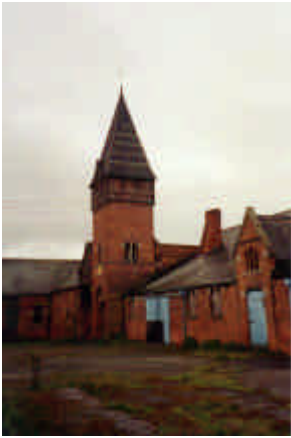
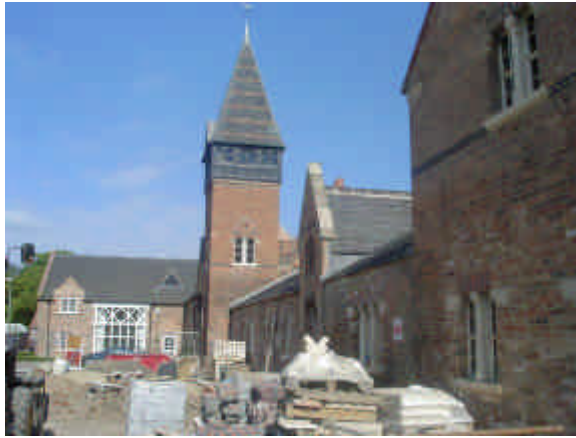
1. The Main Building

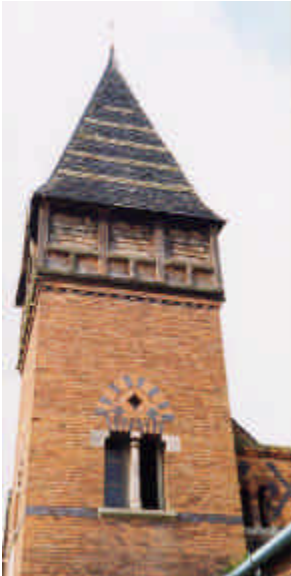
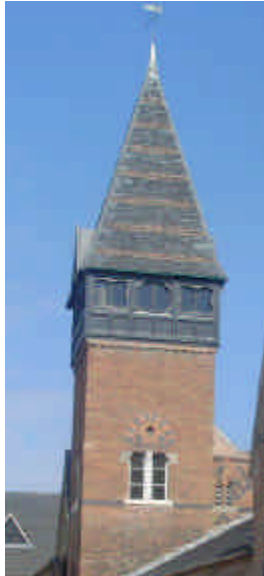
2. The Square Tower

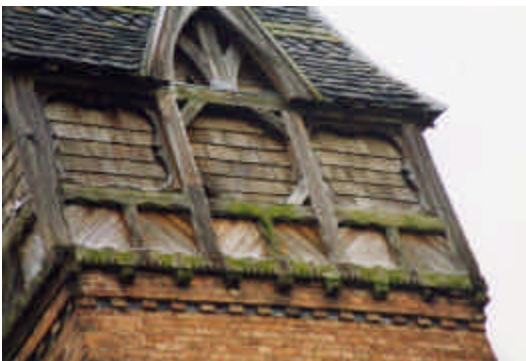
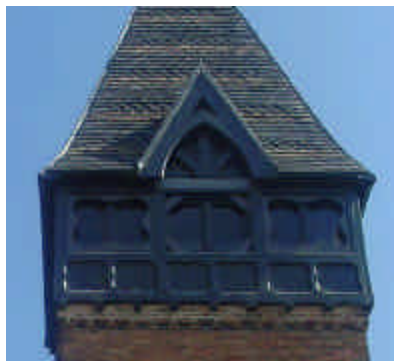
3. The tower was re-roofed and the timberwork restored

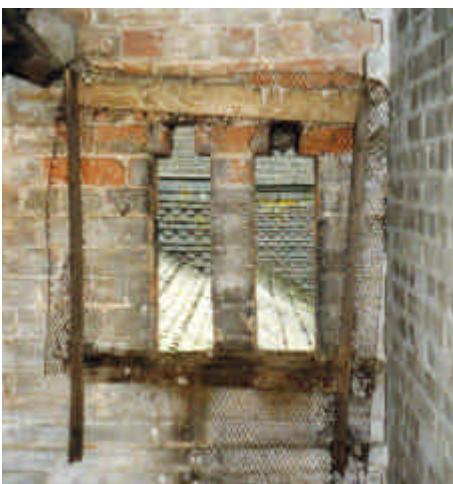
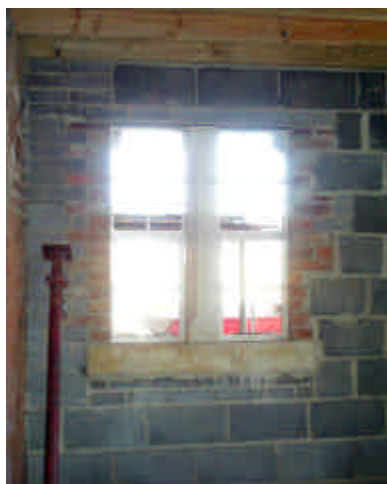
4. The creation of a window opening in a similar proportion to the old

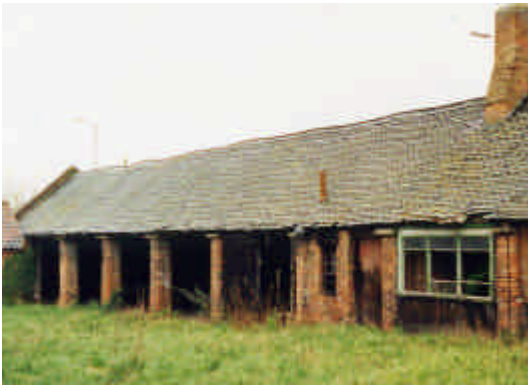
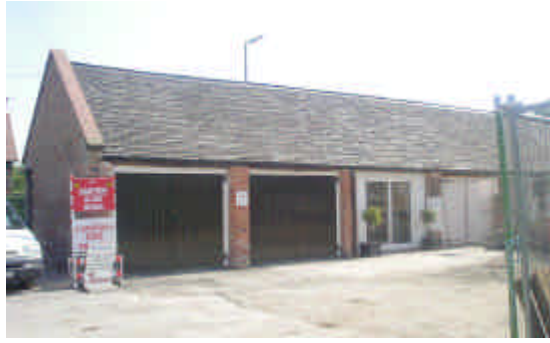
5. Outbuildings restored and converted to garages

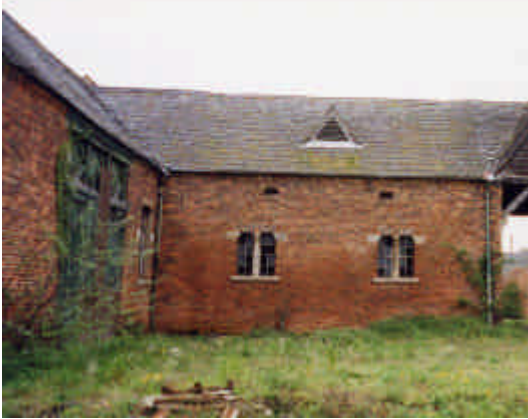
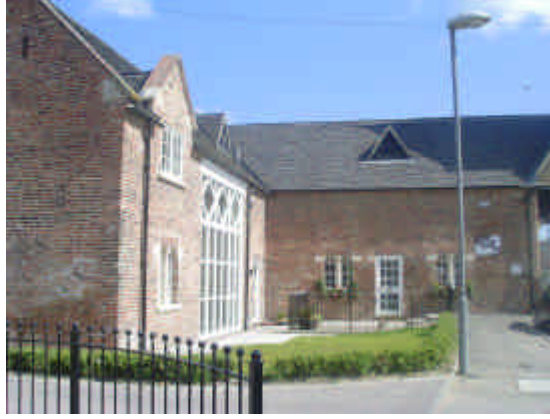
6. The creation of courtyards and the maintaining the existing proportions

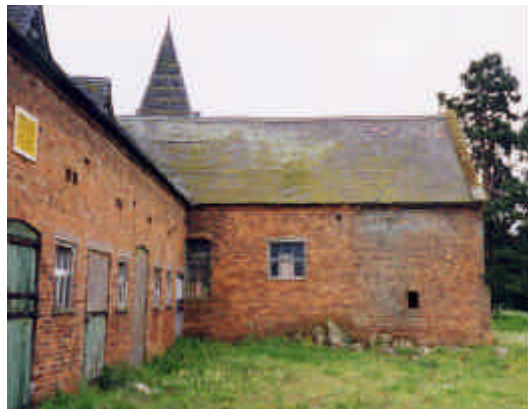
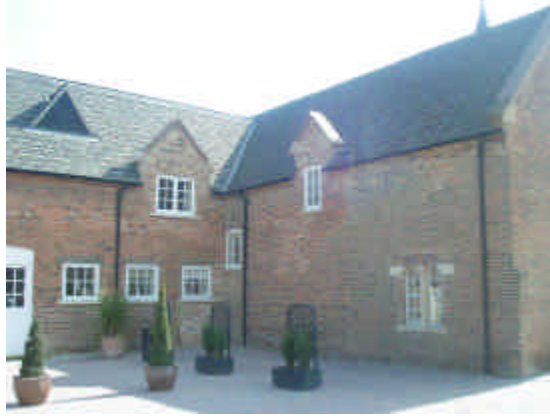
7. Dormer windows subtly added in the style of those existing and other openings formed or closed to suit

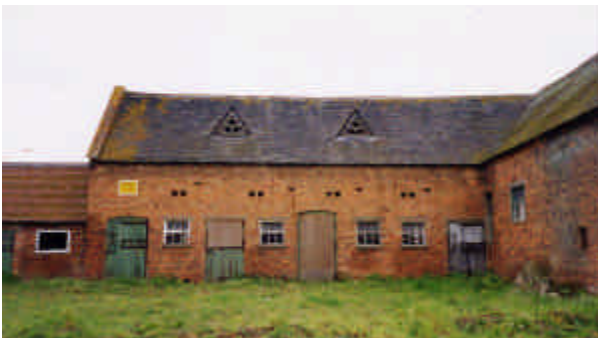
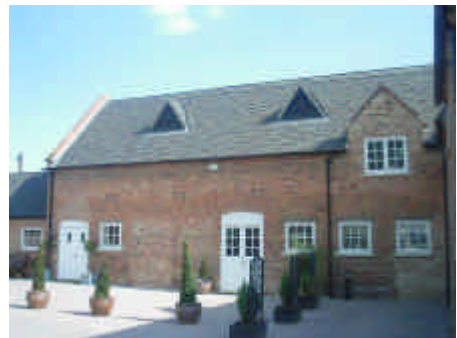
8. A conversion from a series of stables to homes

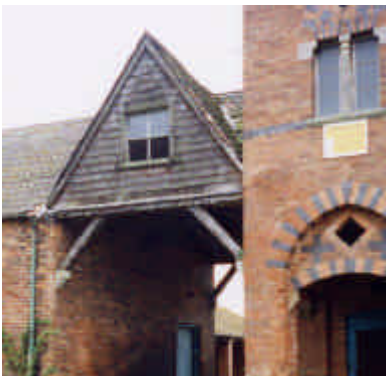
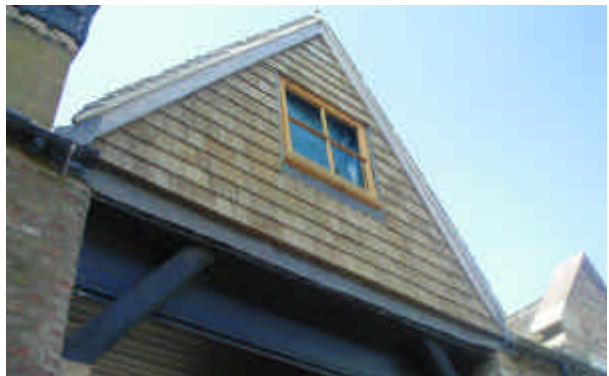
9. New windows, re-clad and re-roofed with timbers restored to match existing

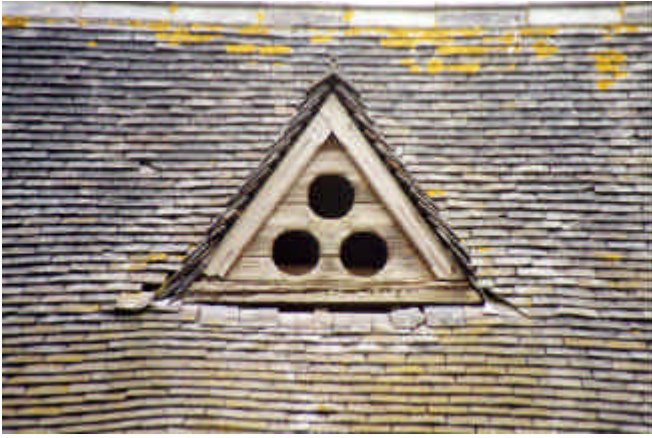
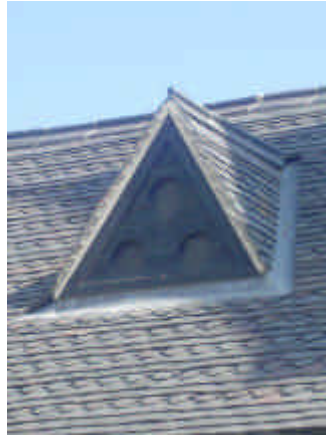
10. Existing features were restored and then repeated further on in the development

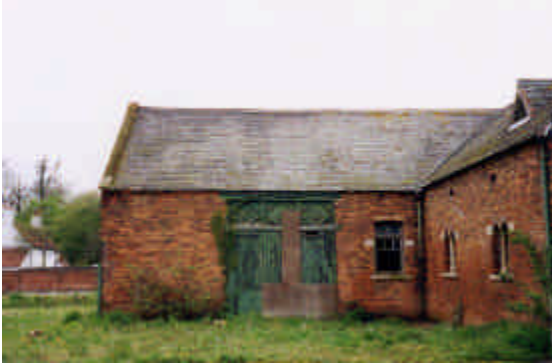
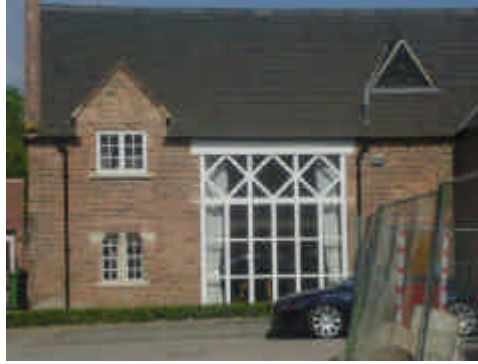
11. A single storey double height barn converted to two storey homes

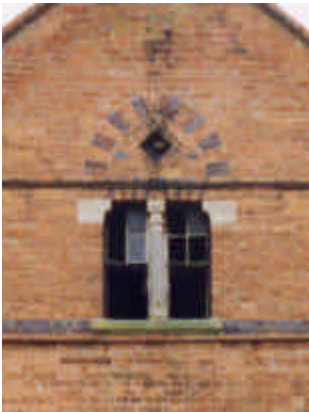
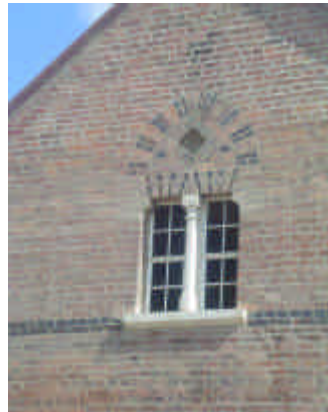
12. The restoration of a dilapidated typical window at Kelham Farm

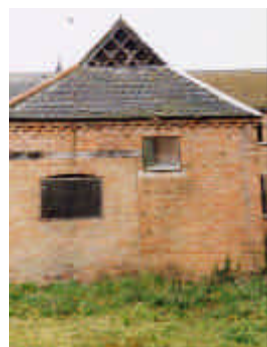
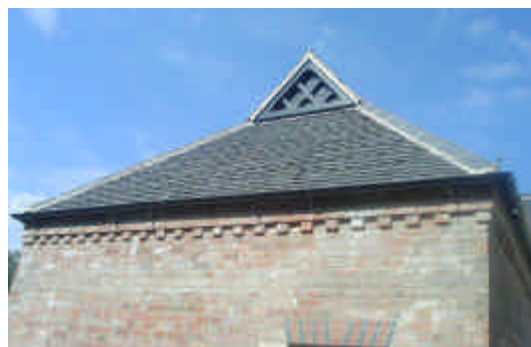
13. Again details were restored to their former glory

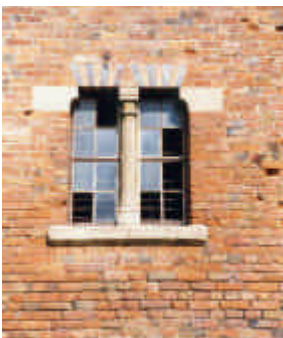
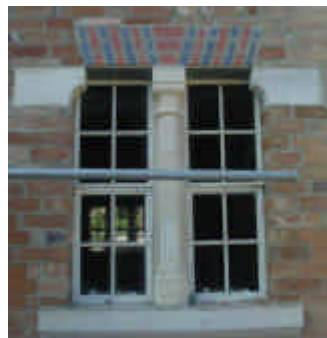
14. Window details were restored and then replicated throughout the development

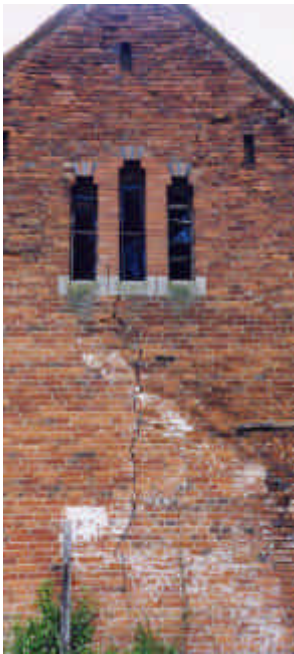
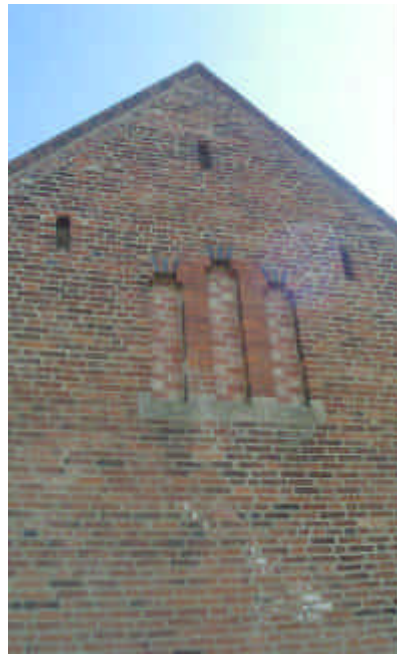
15. Severe cracking and deterioration was repaired

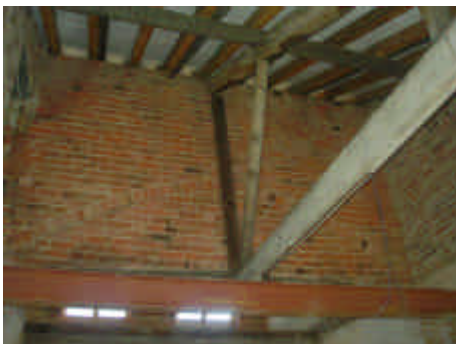
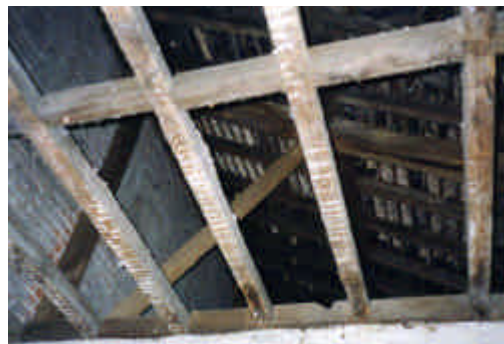
18. The whole roof structure underwent a programme of full restoration and repair
