Project 2: *Repairs to 15th Century roof at St. Peters' Claybrooke Parva, Leicestershire, Diocese of Leicester*

Listing Status: *Grade 1*

Client: *PCC St. Peter's Church Claybrooke Parva,
The vicarage,
Claybrooke Parva, Leicestershire*

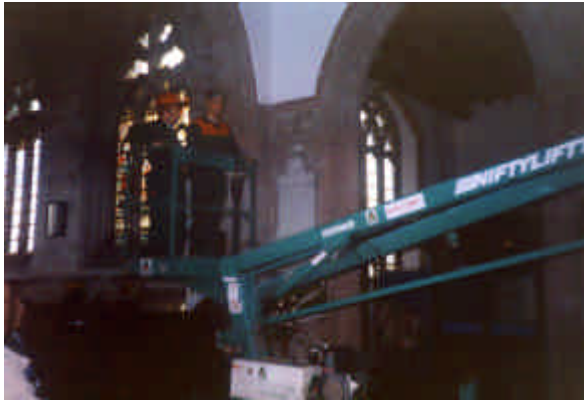
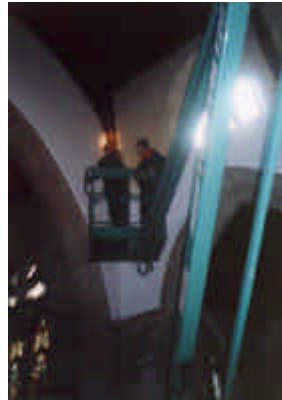
1. Based upon the findings from the quinquennial reports observations, a platform lift was hired to inspect the trusses over the nave to the church

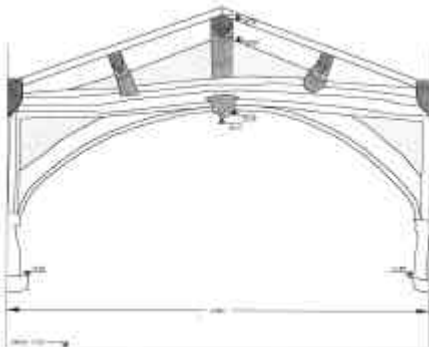
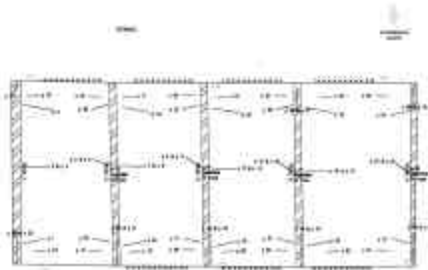
4. A specialist survey team are commissioned by ourselves to carry out a survey of the trusses giving basic outline dimensions and forms

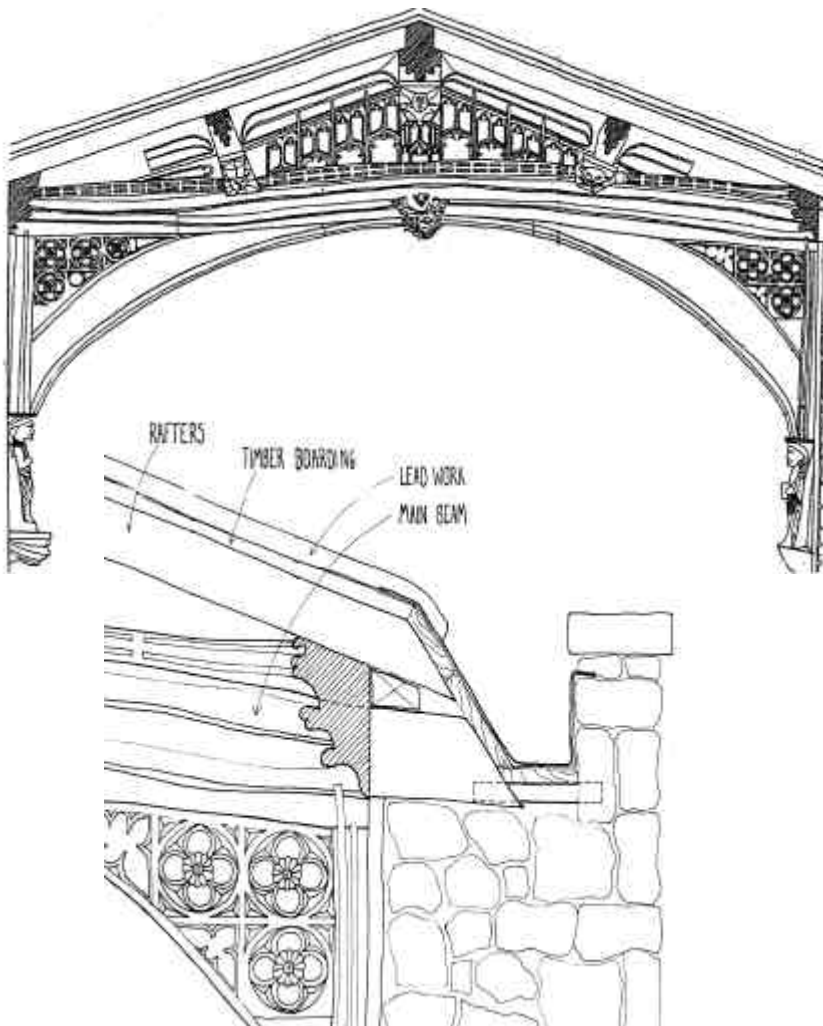
5. The survey team produce measured drawings of the trusses

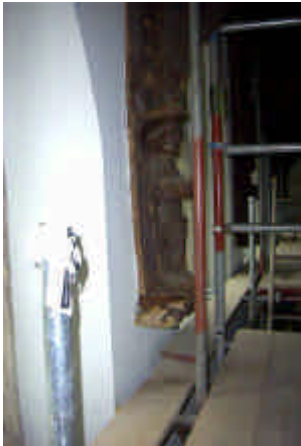
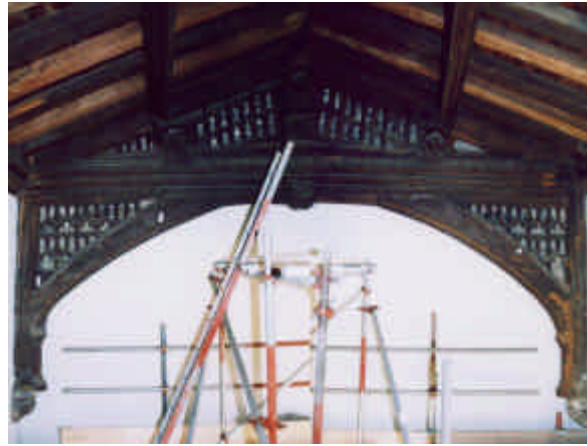
6. From these measured drawings we produced a series of truss elevations that show, with some level of detail, the ornate carvings

7. This enables us to attempt to understand without actually opening up the roof structure the detail of the gutter and truss arrangement and how the roof problems may be occurring

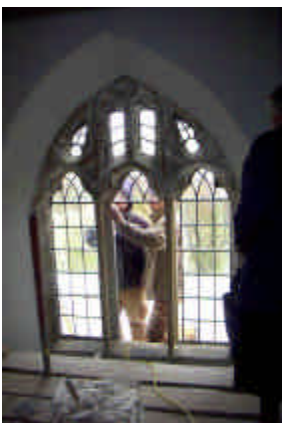
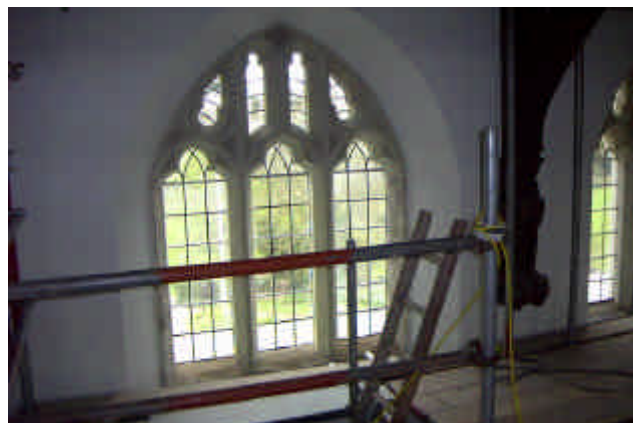
13. These photographs show the extent of the damage to the tracery of the clerestory windows. During the repair of the trusses and whilst the scaffolding was in place
