## **Project Details**

Project 1: *High Level Repairs to St. Peter's Church, Witherley  
Diocese of Leicester*

Listing Status: *Grade 1*

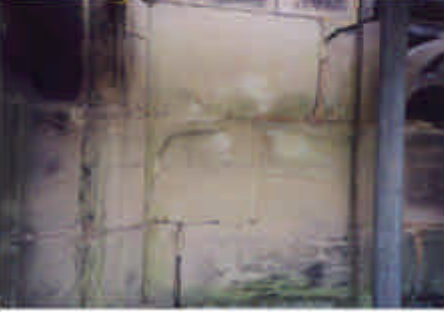
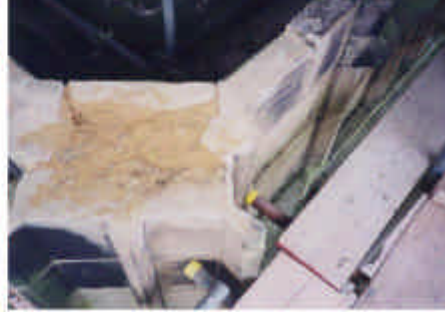
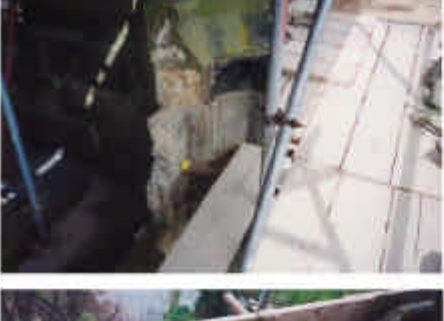
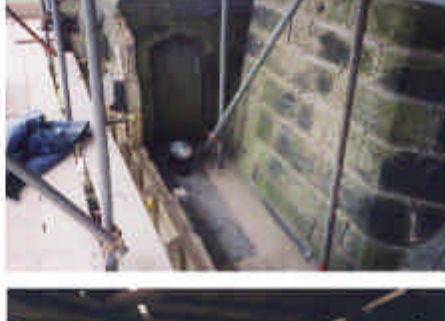
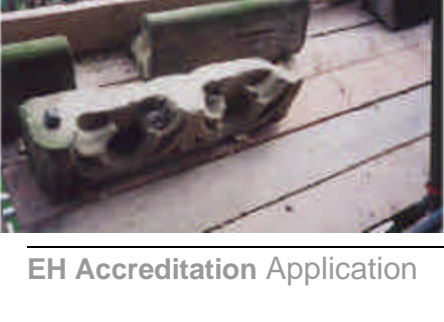
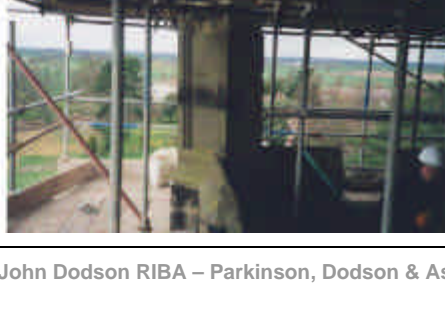
7. The base of the pinnacles were distressed due to poor initial and original construction and the use of too small sections of stone which give only limited bonding to other elements of the tower walls.

8. New Woodkirk stones to new dimensions were dressed into the walling to provide a sound and stabilized base for the reconstruction of the pinnacles. At parapet floor level a ring of stainless steel Helitie was inserted in the bed joint and extended into the bed courses of the pinnacles, this provided continuity of reinforcement into the pinnacle structure. This reinforcement was repeated just below the battlement level.

9. As the pinnacles were being reconstructed the parapet battlements were also being rebuilt, this allowed for bonding between pinnacle and walling to be improved. A percentage of the decorative frieze stones forming the battlements had to be replaced due to delamination, but care was taken to reuse the original stonework wherever possible.

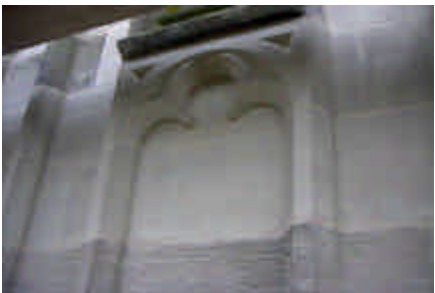
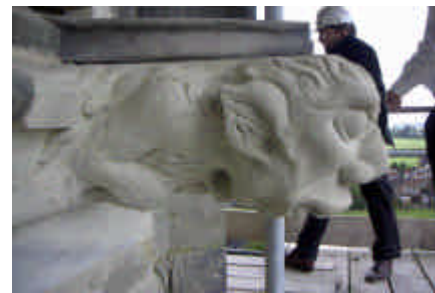
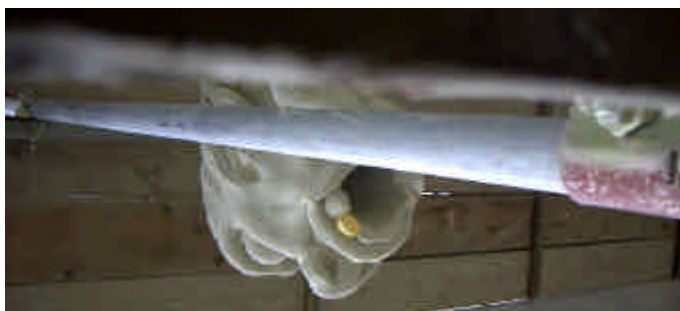
11. The original gargoyle on the southeast corner was severely weathered and the underside of the stone had weathered back as to make the stone unsafe. The stone was carefully supported and cut away and retained for reference. The new gargoyle, complete with gold leafed tooth, was installed.
